CITY OF FALLS CHURCH

Development Services Department Staff Report Addendum

SUBJECT: **SITE PLAN 20090057 - 6607 Wilson Boulevard, BJ's Wholesale Club**

DATE: March 27, 2009

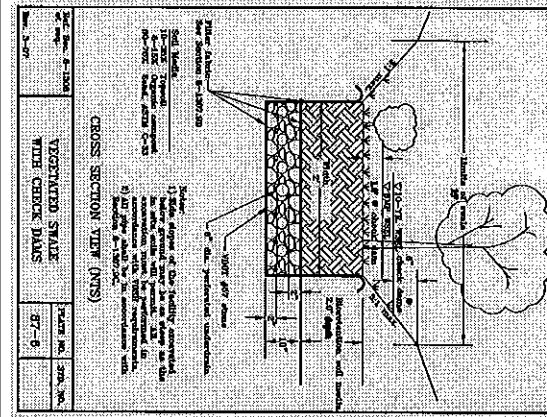
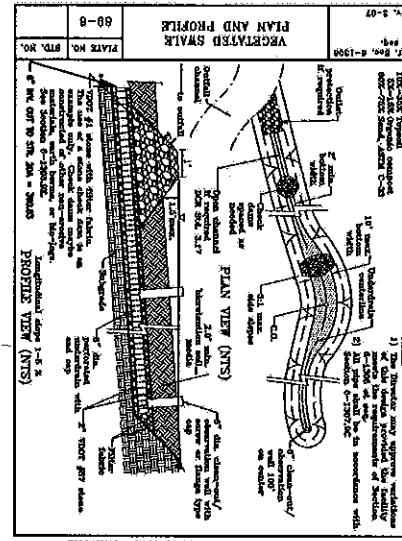
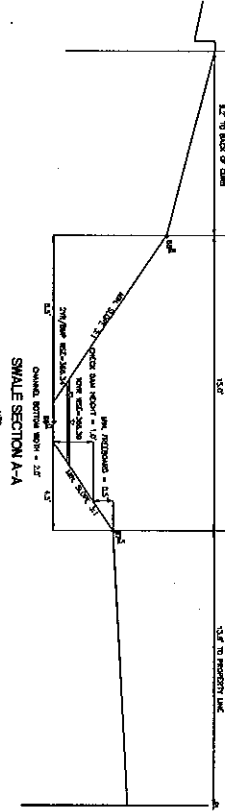
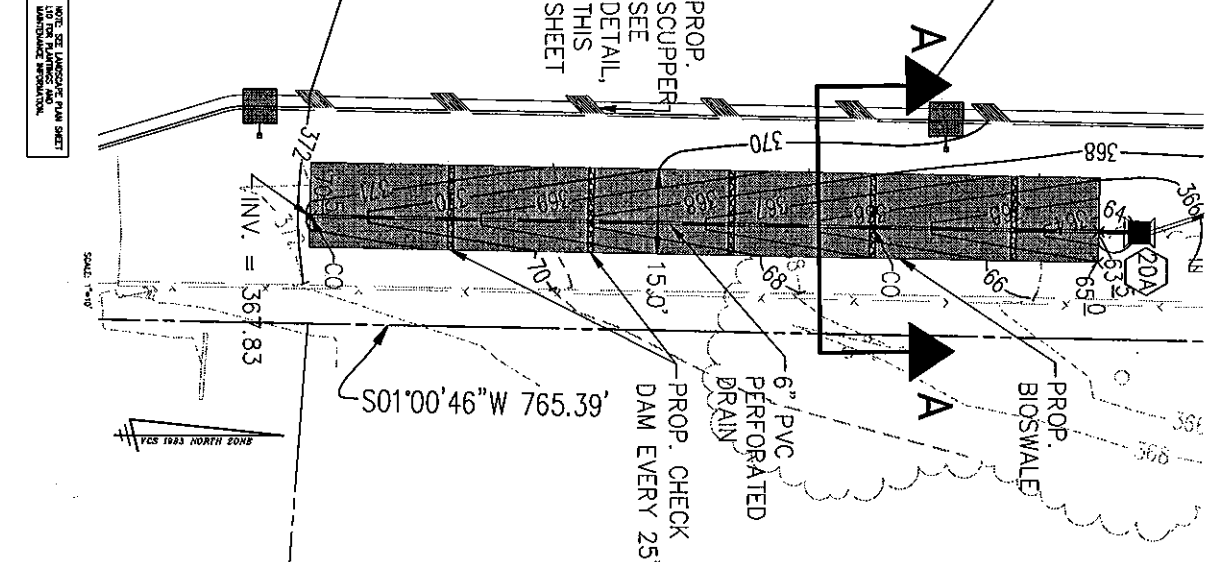
BIOSWALE COMPUTATIONS AND DETAILS

BIOSWALE COMPUTATIONS

BASED ON VEGRETATED SWALE SPECIFICATIONS IN THE
FAIRFAX CO. PWD CODE, 6-1-2008

(1) DETERMINE CHECK DAM HEIGHT, SPACING AND CHANNEL CROSS-SECTION FOR A
WATER QUALITY VOLUME (WQV) OF 0.5 FROM THE WETTED AREA (WQV 0.5)

(2) DETERMINE PROPOSED CHECK DAM HEIGHTS
CONSIDERING ROADS AND LOCATIONS FOR THE STAFF (TABLE 6.3 FROM PWD CODE, PWD)

Since original submission, the applicant has worked to address the staff recommendation to install green elements on the site. The attached document (Attachment 1) is a newly planned bioretention swale that was submitted this morning and is currently under review by the City Engineer's office. Staff recommendation and appropriate site plan pages will be provided with the public hearing package.

Attachment 1 Bioretention swale exhibit
